National Register of Historic Places Inventory—Nomination Form

historic Rockdale (preferred)

street & number 1724 Carrs Mill Road

city, town Fallston

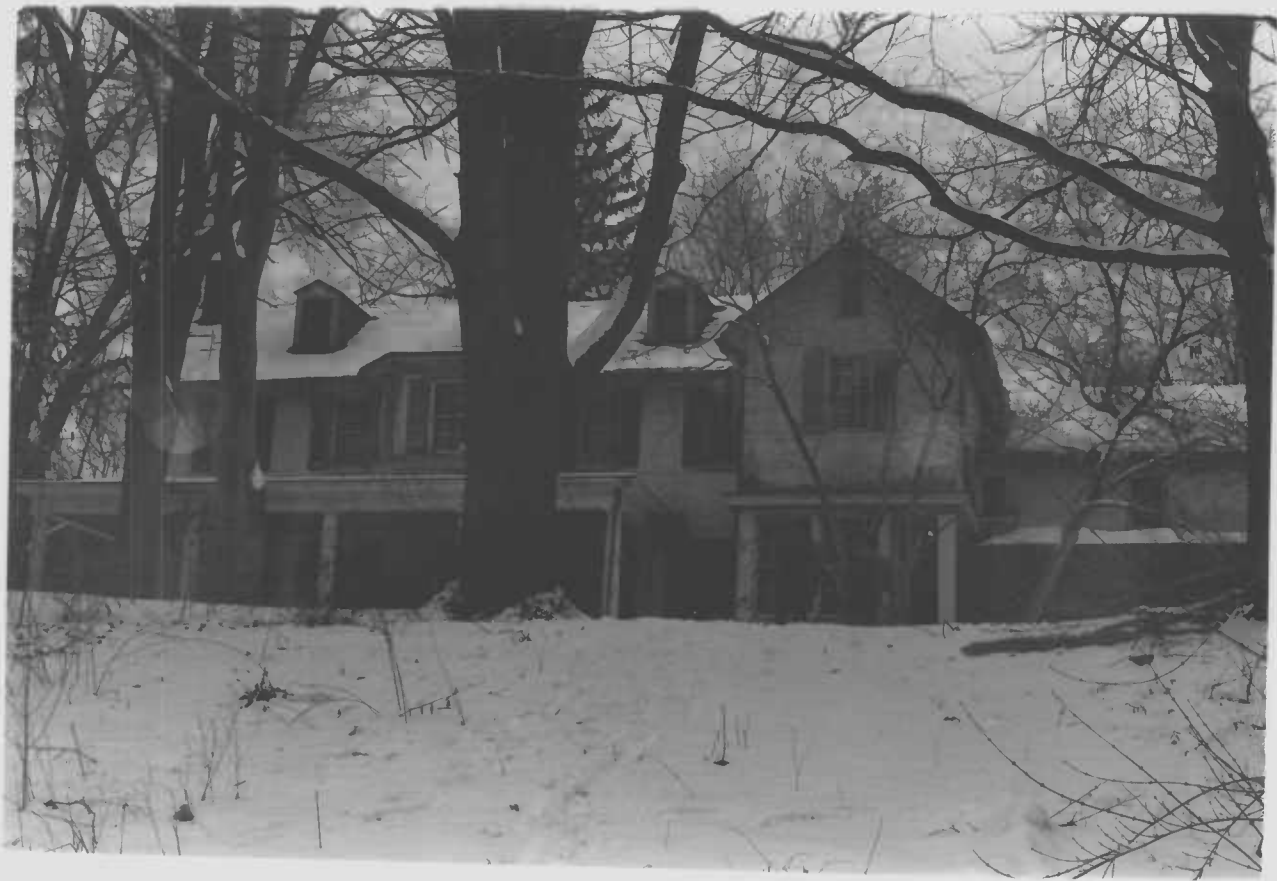
Rockdale HA-1229
Fallston, MD 21047
Susan M. Deeney
February, 1978
Southeast

The main house is five bays in length, two and one-half stories in height, of stone construction, stuccoed and scored. A brick chimney rises flush with each end gable. The principal entrance centered in the south front is a six paneled door with glazed transom. Typical windows are 6/6 with narrow beaded frames and louvred blinds. Three dormers are in the southerly slope of the roof, each with 6/6 windows. A one-story porch extends across the south front, its fluted wooden columns of the Greek Doric order. Originally three bays in width, it was extended the full length of the house early in the 20th century. The bay window, added early in the 20th century to the central bay of the second story, has a 6/6 window in its south side with 4/4 windows in the flanking sides.

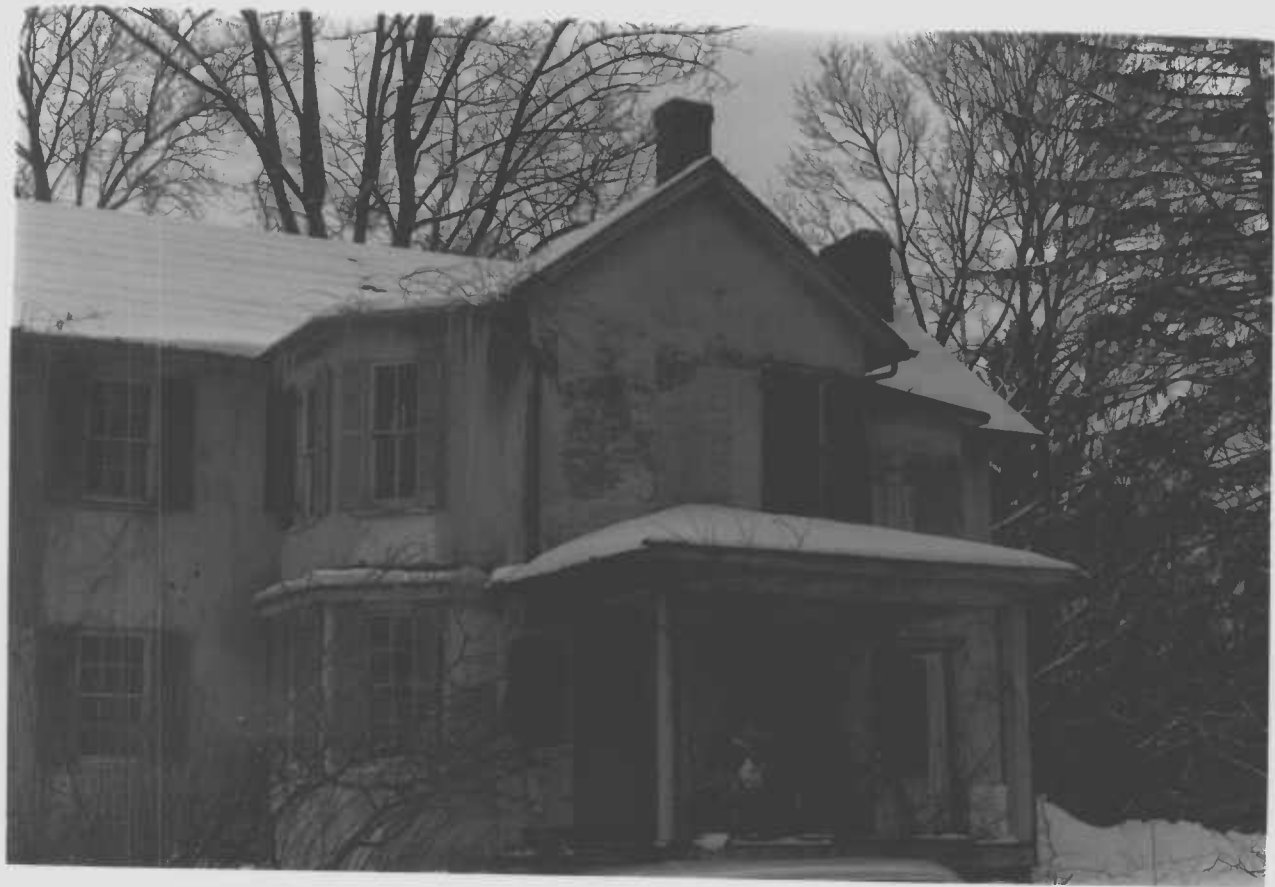
Rockdale HA-1229
Fallston, MD 21047
Susan M. Deeney
February, 1978
North

The north facade is similar to the south but its central bay is covered by the north wing, an early 20th century addition of frame construction stuccoed over wood lath over weatherboarding. Two stories in height with a gabled roof, it has a two-story bay window projecting from its east side and a small porch sheltering the entrance in the north end.
